Mill & Bradfords Brook Desk Study for 1st Catchment Partnership

James Hubbard

Project Officer Action for
the River Kennet

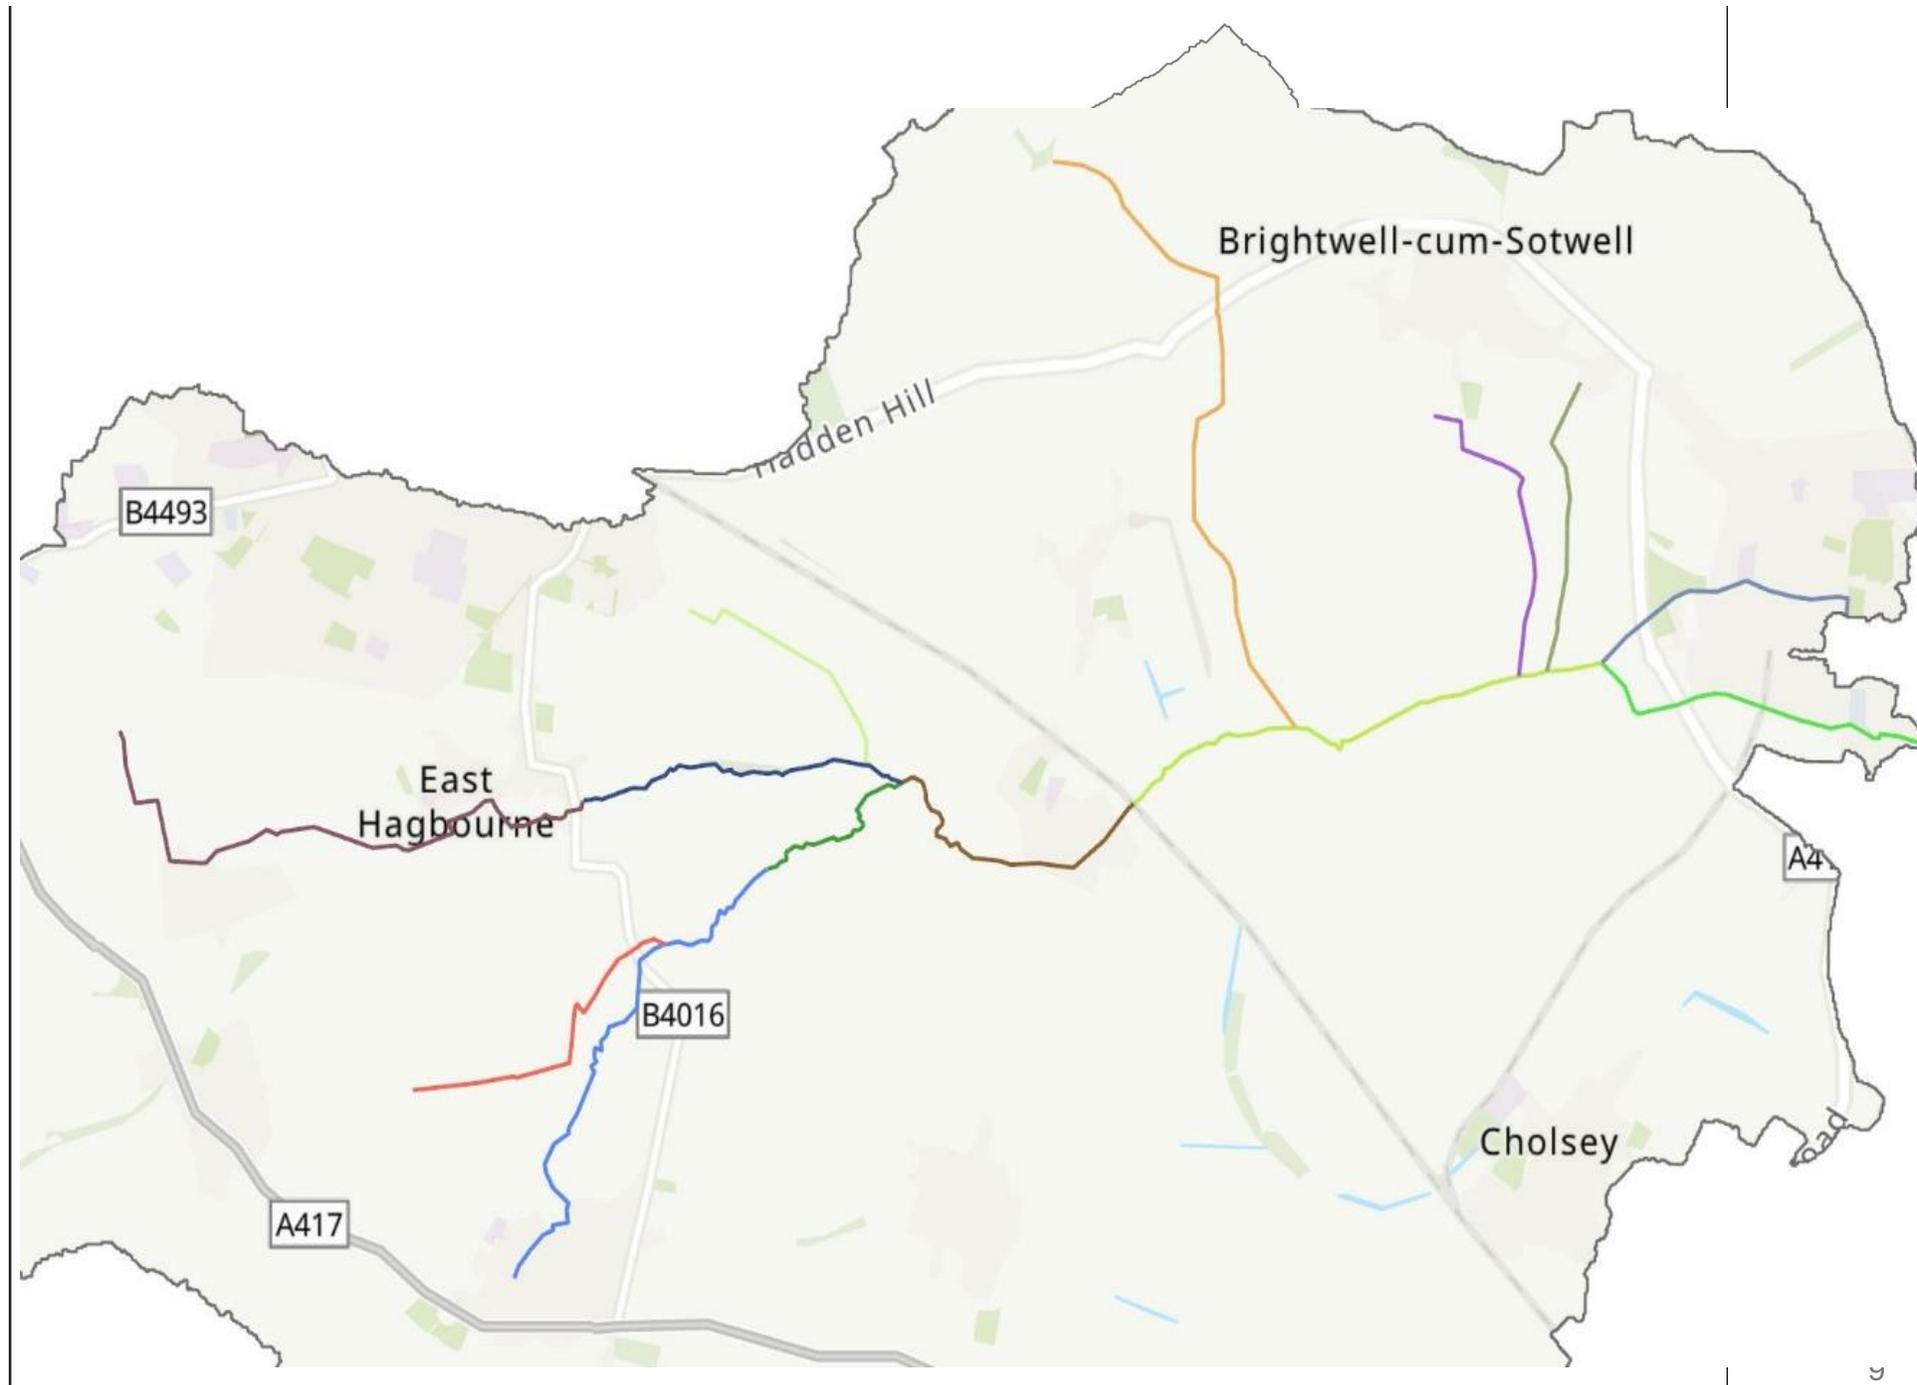
Mill Brook Reach
Definition

- Bradford's Brook:
Hithercroft Sluice-
Thames
- Mill Brook: Hithercroft
Sluice-Thames
- Mill Brook: South
Moreton STW-
Hithercroft Sluice
- Sotwell Ditch: Slade
End-Hithercroft Farm
- Mackney-Hithercroft
Farm
- Kibble Ditch: White
Lees, Brightwell-cum-
Sotwell-Mill Brook
- Mill Brook: Hakka's
Brook junction-South
Moreton STW
- Mill Brook: Mill Brook
continued-Hakka's
Brook junction
- Mill Brook: Blewbury-
Mill Brook continued
- Stream Road Upton-
Hagbourne Mill Farm
- Hakka's Brook:
Blewbury Road at East
Hagbourne-Mill Brook
junction
- Fleet Meadow Didcot-
Fulscot
- The Driftway at West
Hagbourne-Blewbury
Road at East Hagbourne
- <all other values>

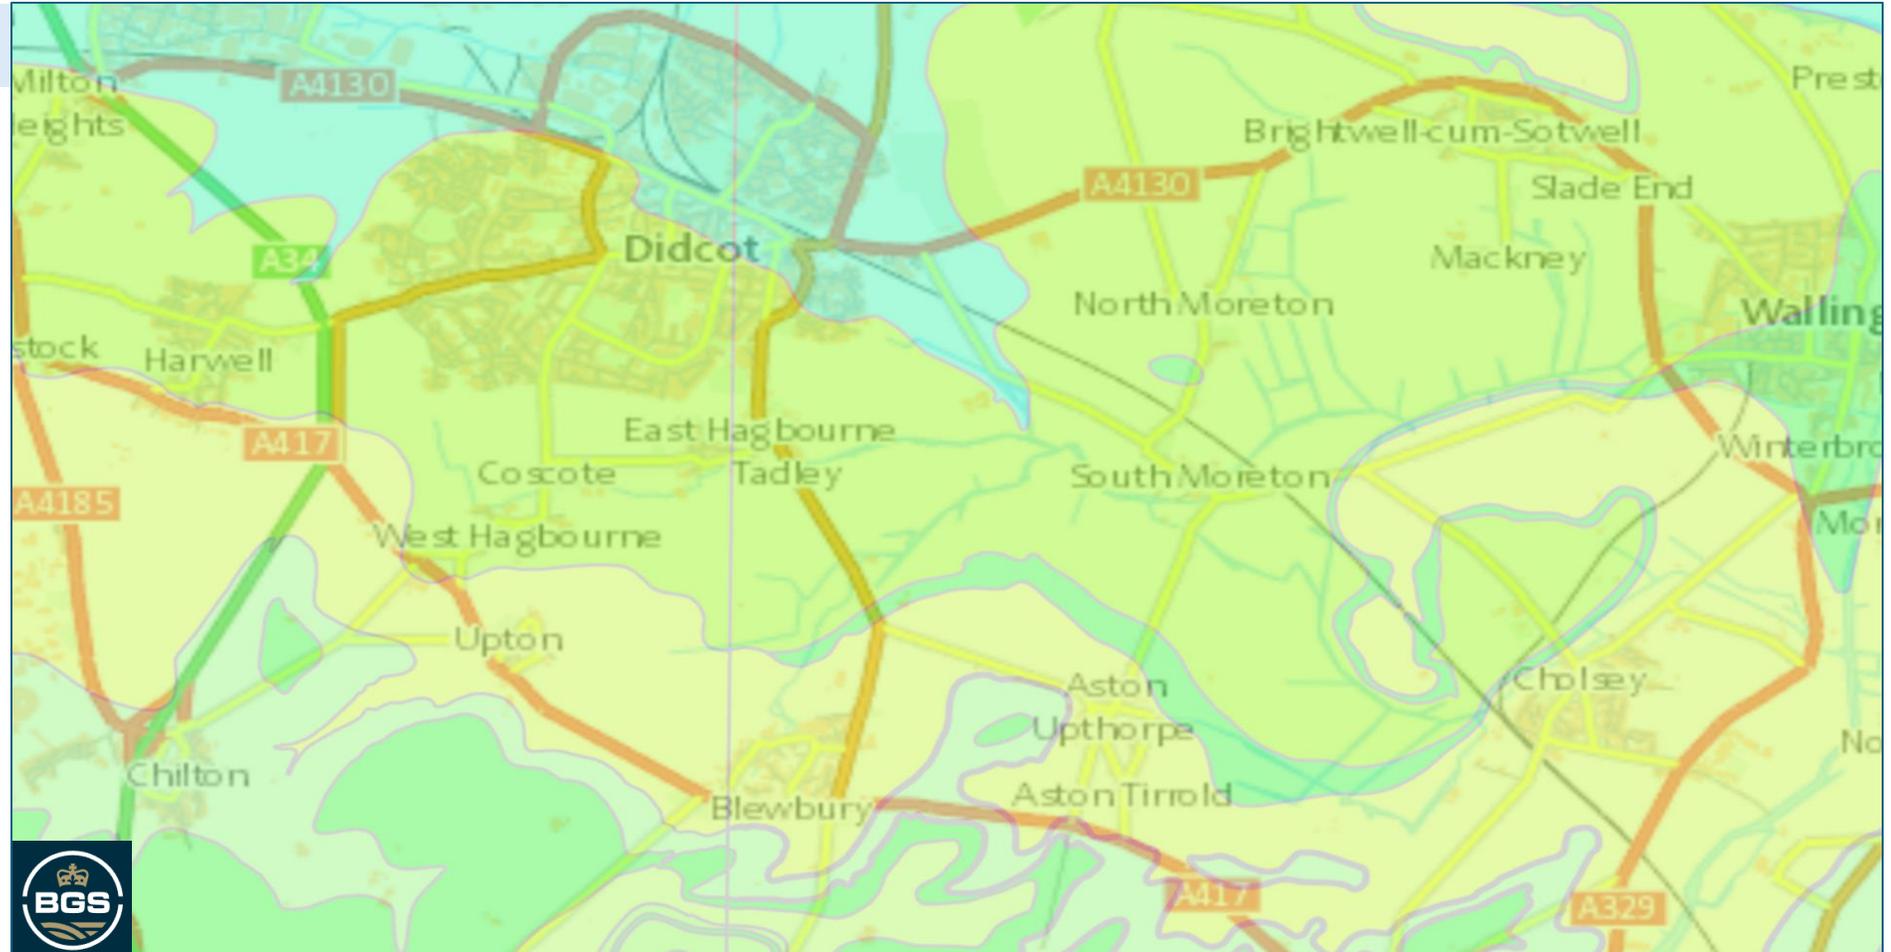
Bedrock

Upper Greensand Formation-Siltstone and sandstone
-

West Melbury Marly Chalk Formation-Chalk
-

Glauconitic Marl Member-Glauconitic sandstone

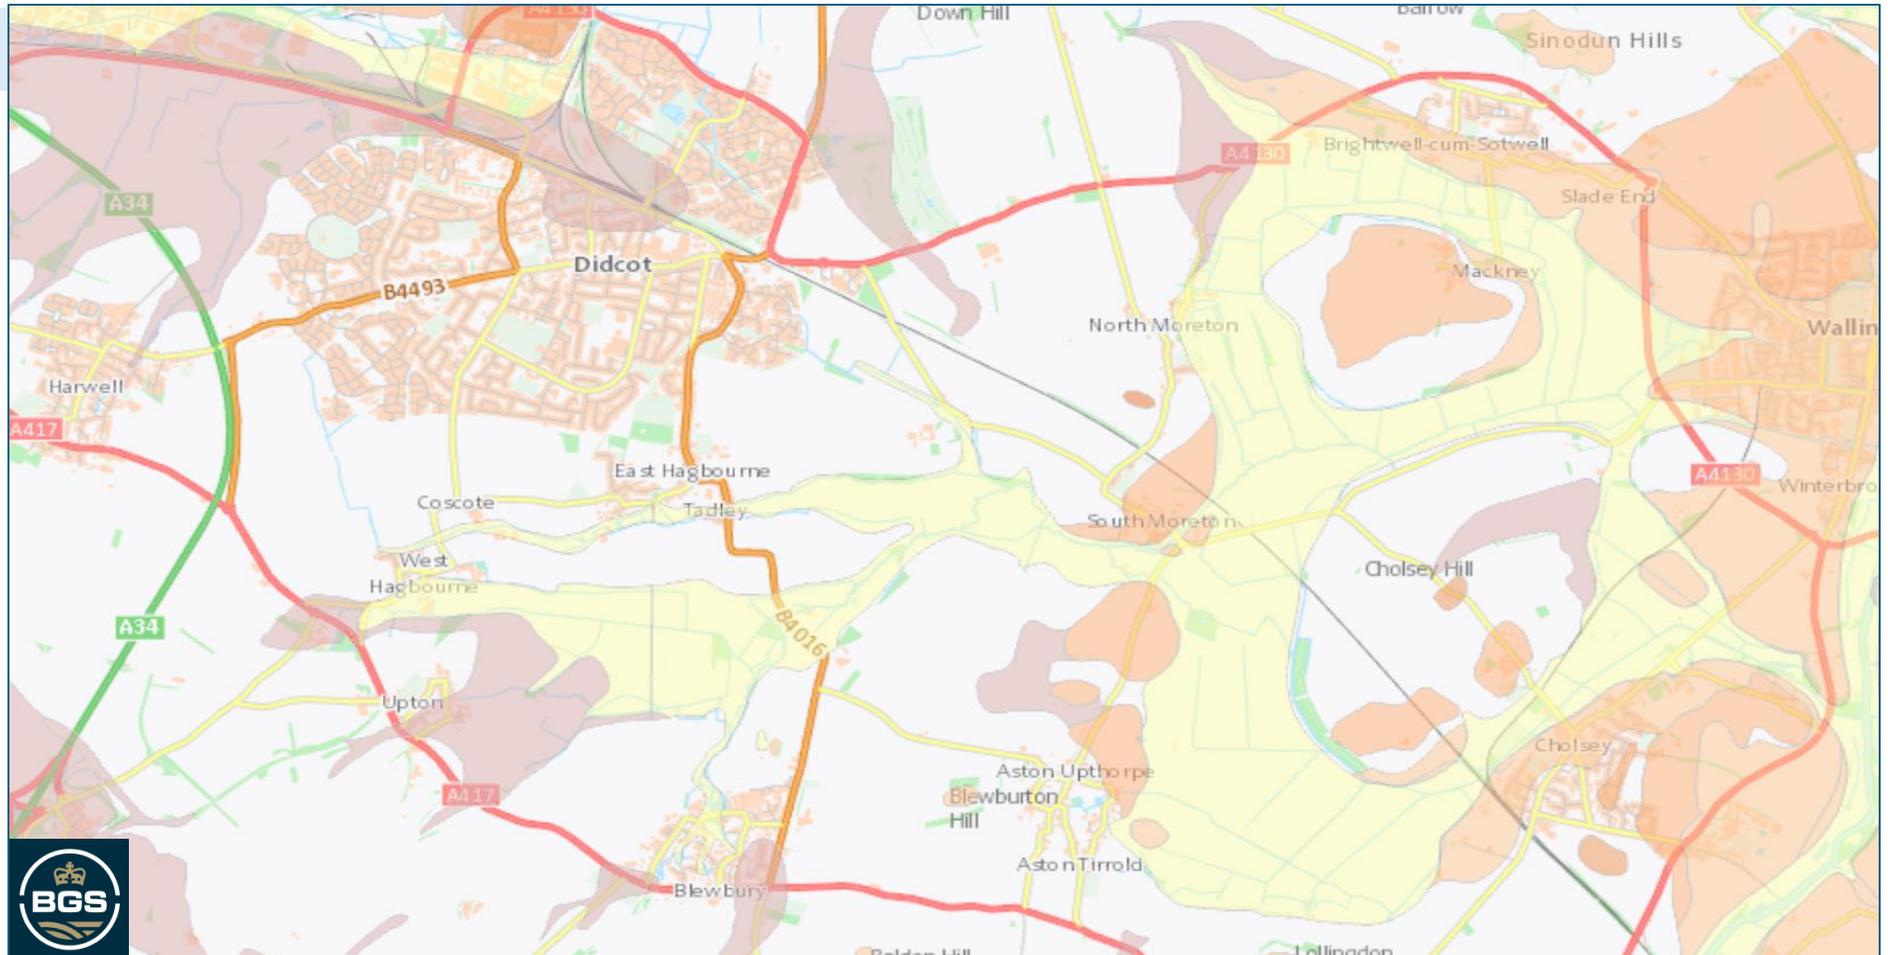
Superficial Deposits

Alluvium-Clay, silt, sand and gravel
-

Summertown-Radley Sand and Gravel Member-Sand and gravel
-

Head-Clay, silt, sand and gravel
-

Northmoor Sand And Gravel Member, Upper Facet-Sand and gravel

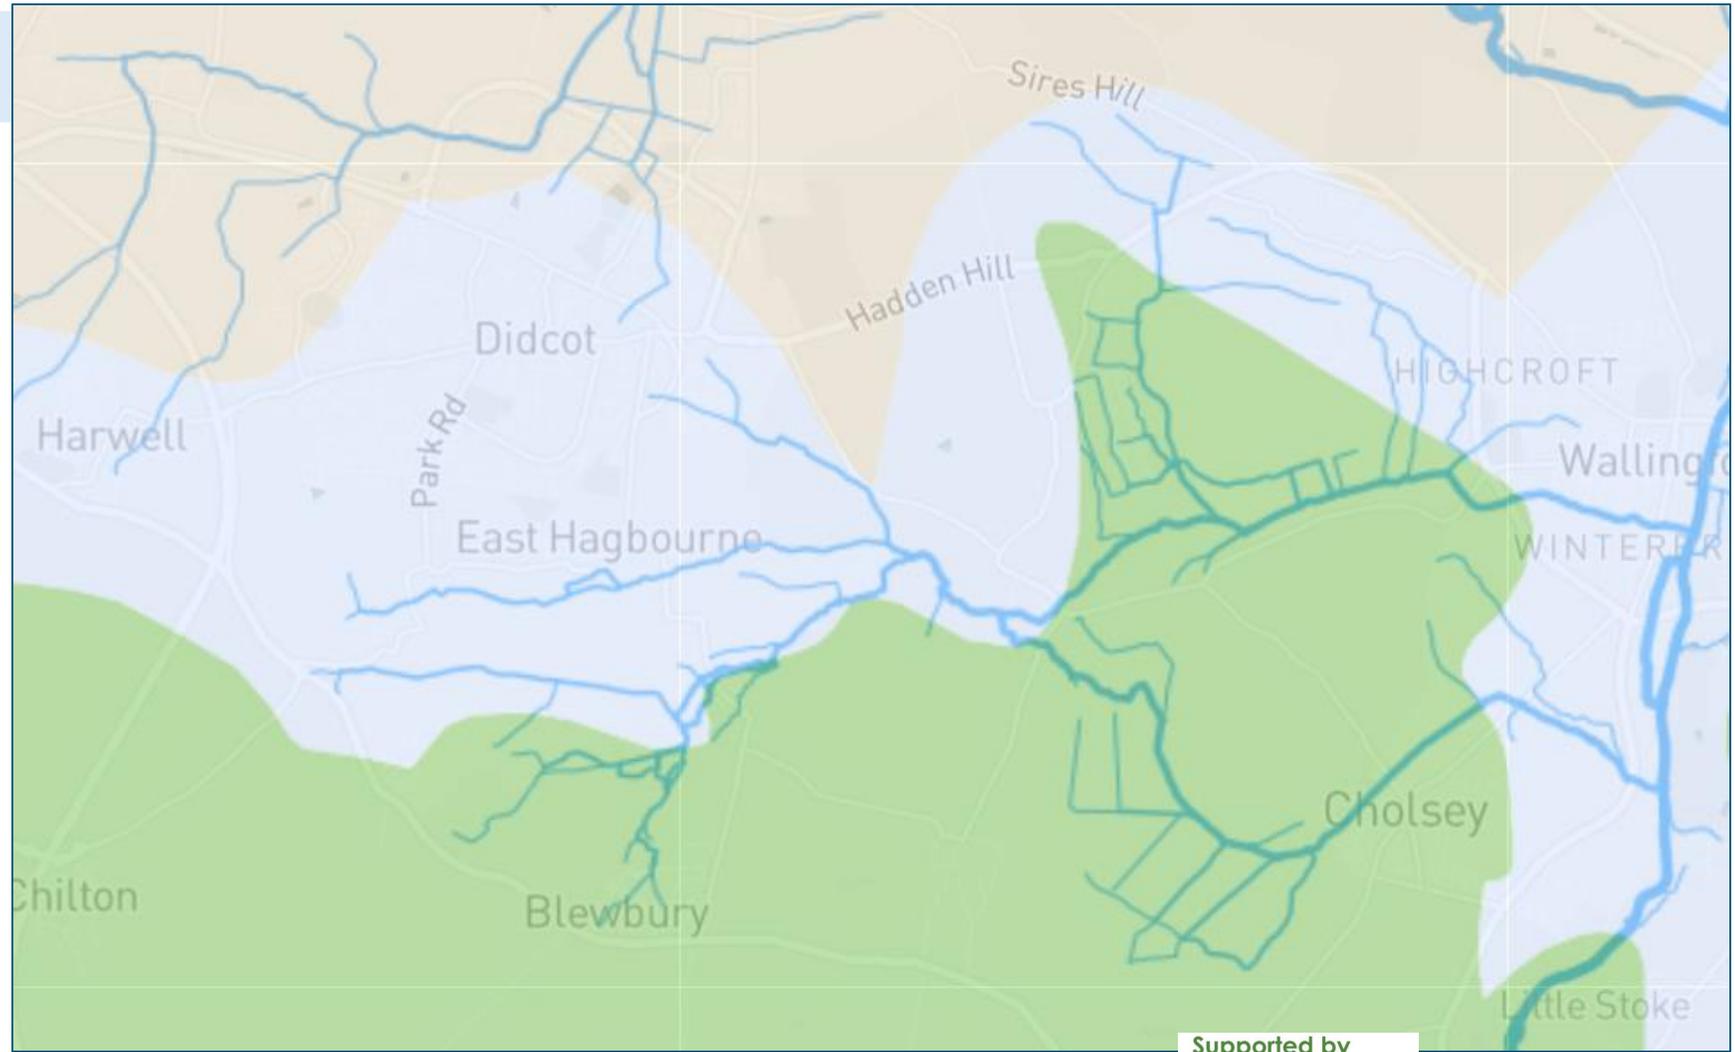
Bedrock Deposits and Groundwater

- High permeability (fissured)
- Moderate permeability (fissured)
- High permeability (intergranular)
- Moderate permeability (intergranular)
- Very low permeability
- Mixed permeability

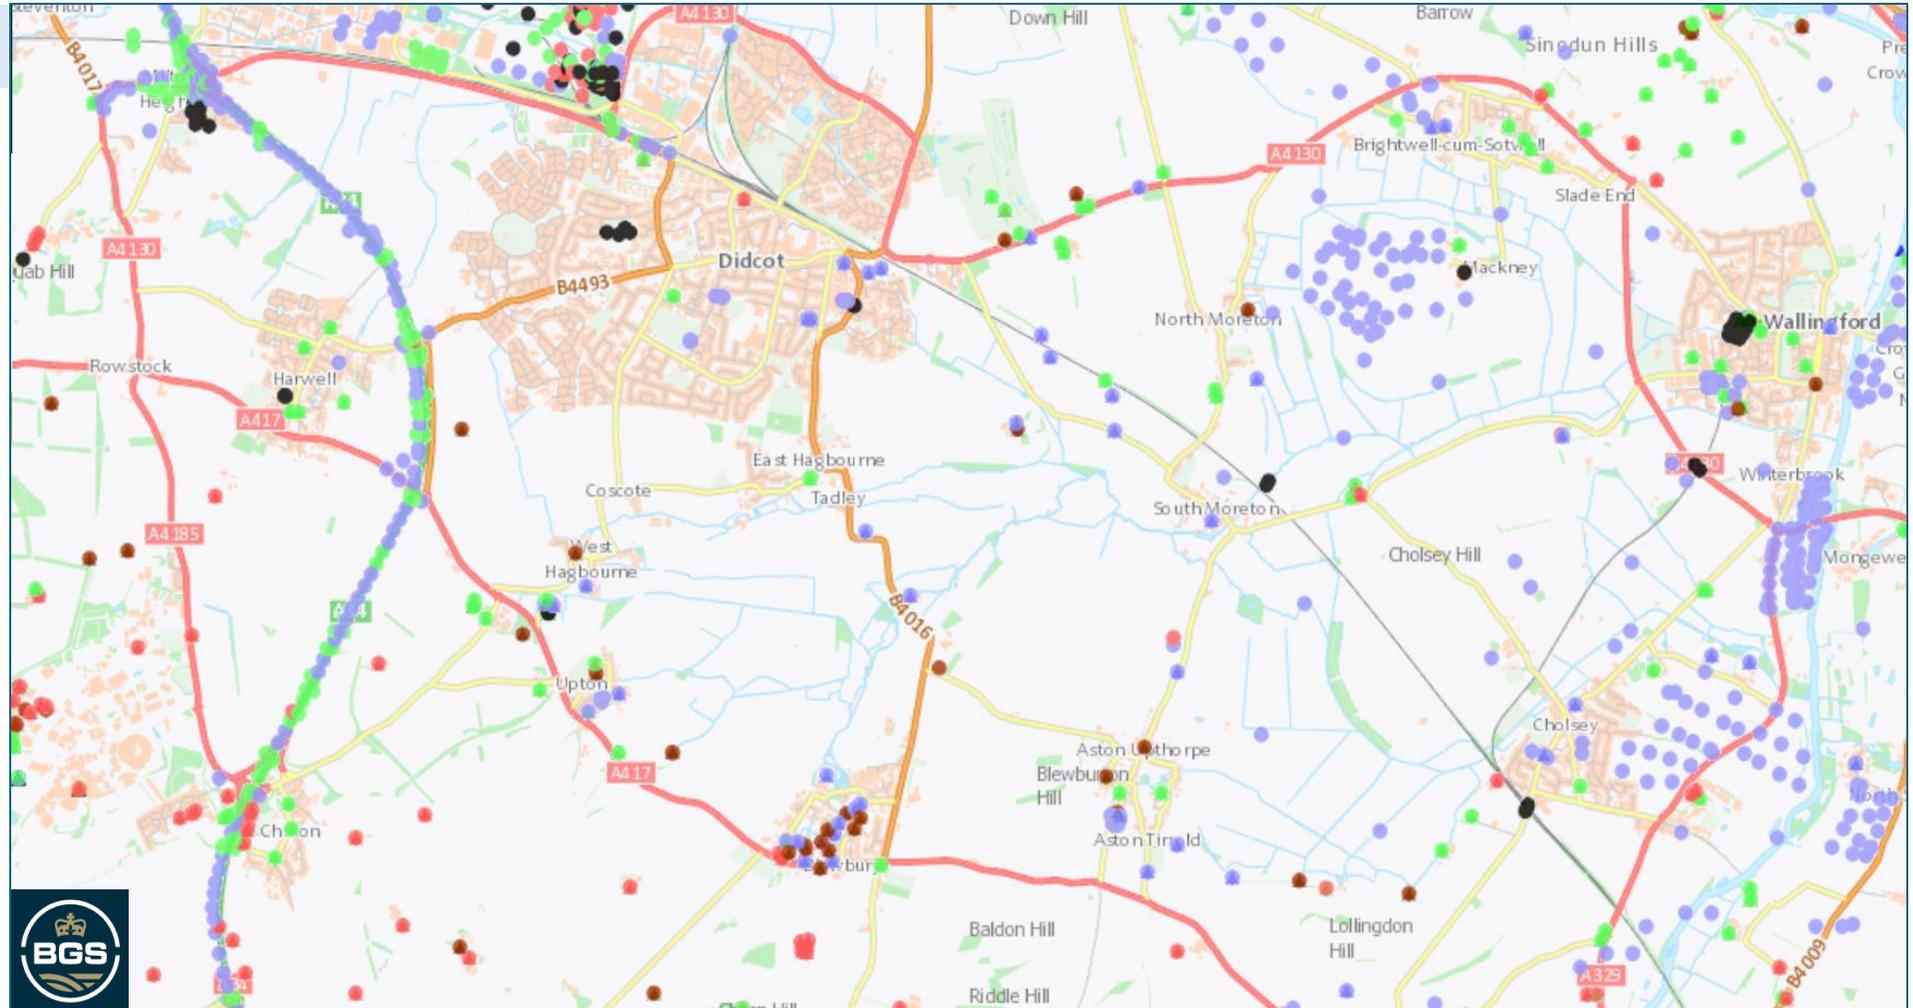
Groundwater

- ▲ Not Available
- ▲ 0 - 10m
- ▲ 10 - 30m
- ▲ 30m+

- Unknown Length
- Confidential
- 0 - 10m
- 10 - 30m
- 30m+

British Geological survey records of well depth provide an indication of groundwater levels

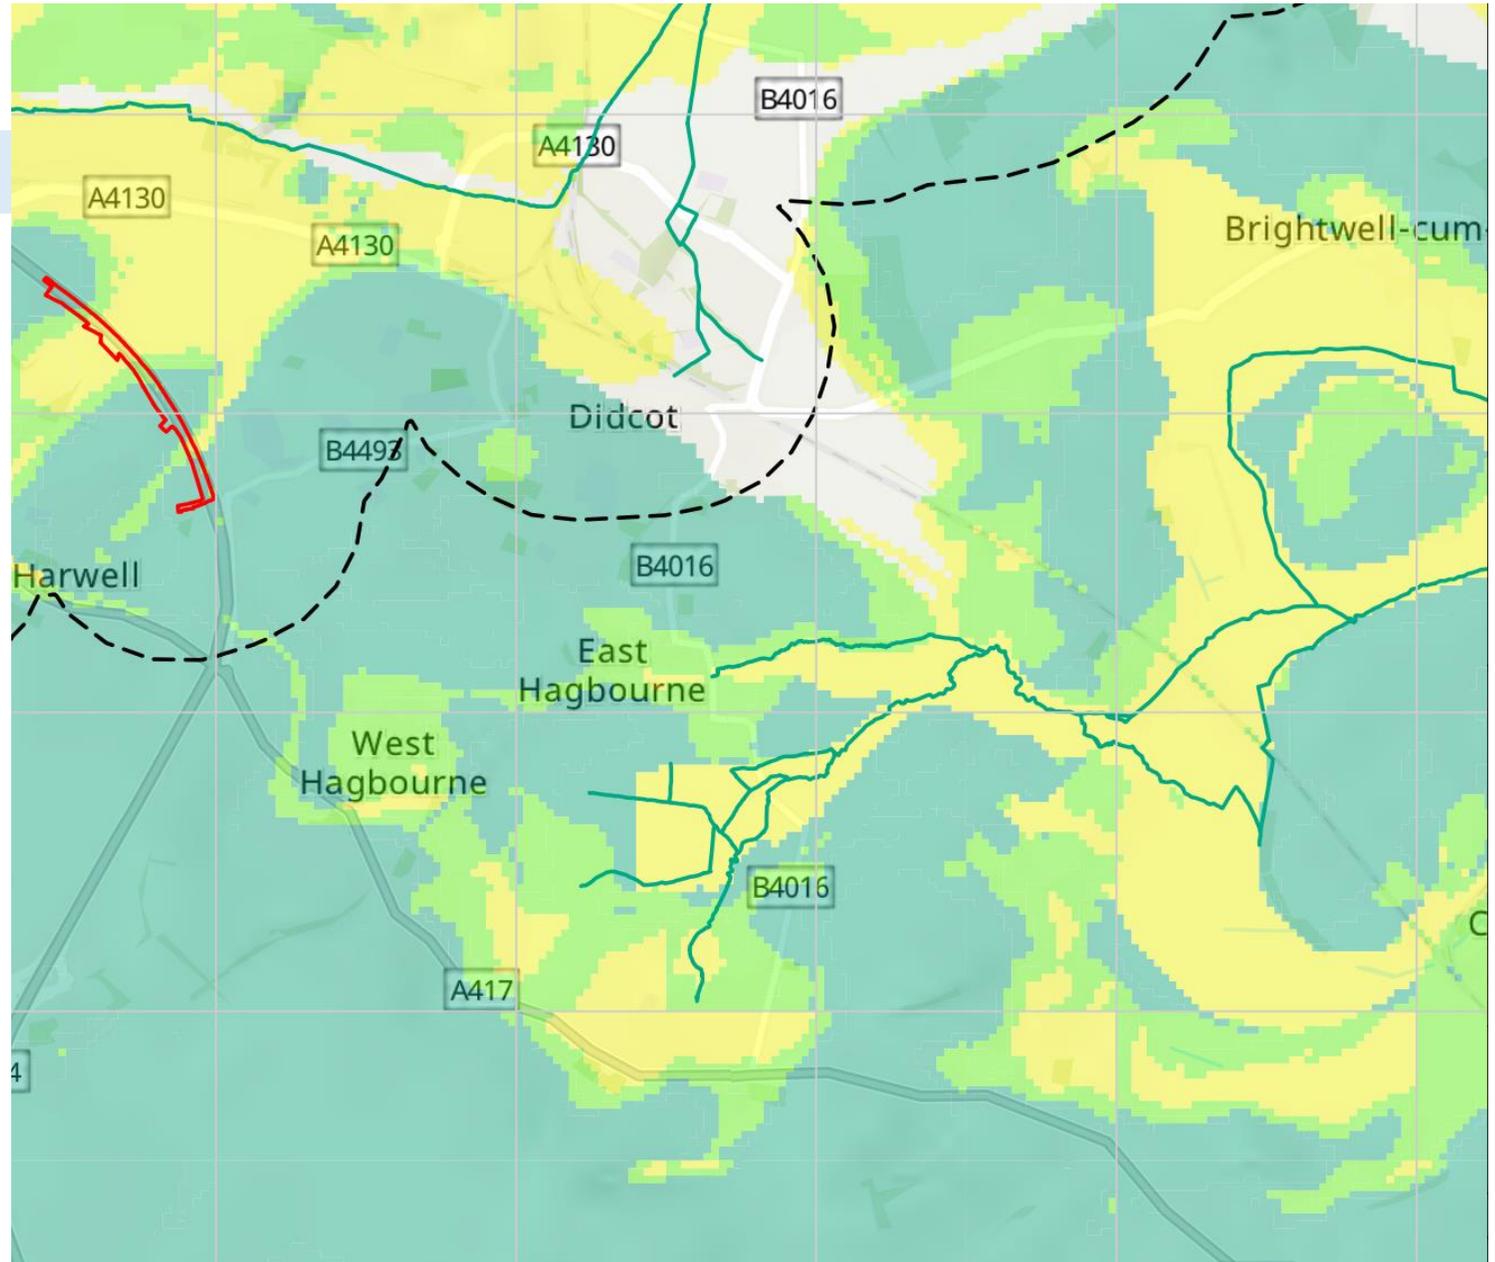
Modelled Groundwater Flooding

Geological mapping performed for
catchment assessment in reservoir
construction

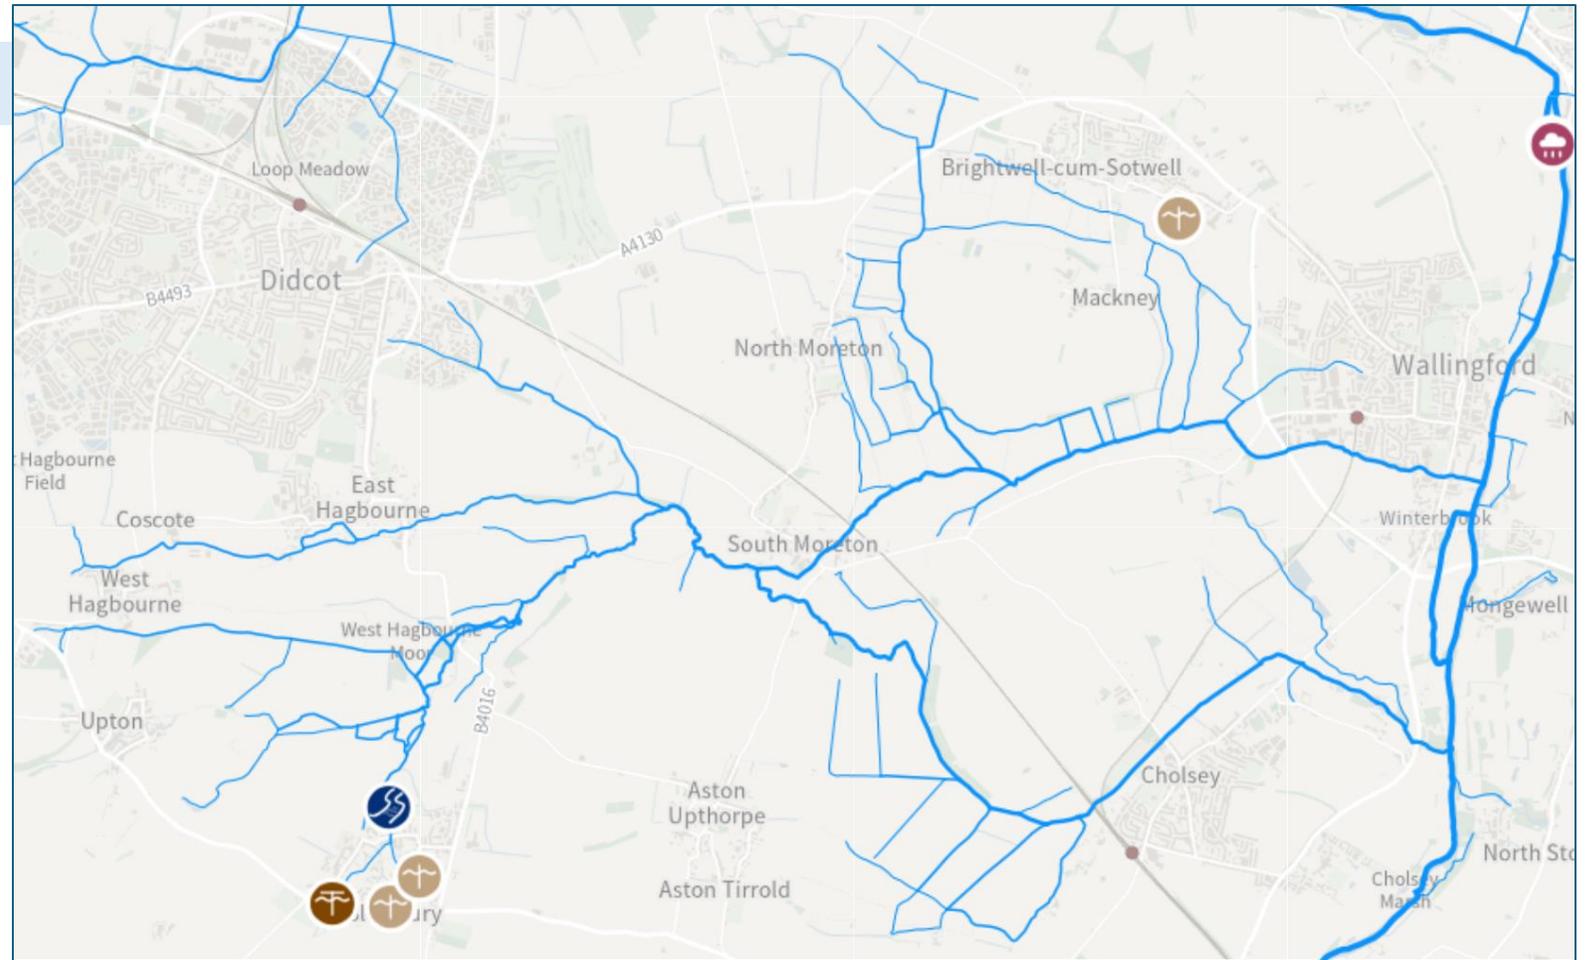
EA Hydrology Data Explorer

Rainfall : 15 minute resolution at [Benson Lock](#)

Groundwater Dipped: Sporadic (1 month–annual) at [Longwall Cottage](#), Mackney

Groundwater Level: Hourly at [Brookside Blewbury](#)

River Flow: 15 minute resolution at [Blewbury](#)

Water Quality: No continuous monitoring

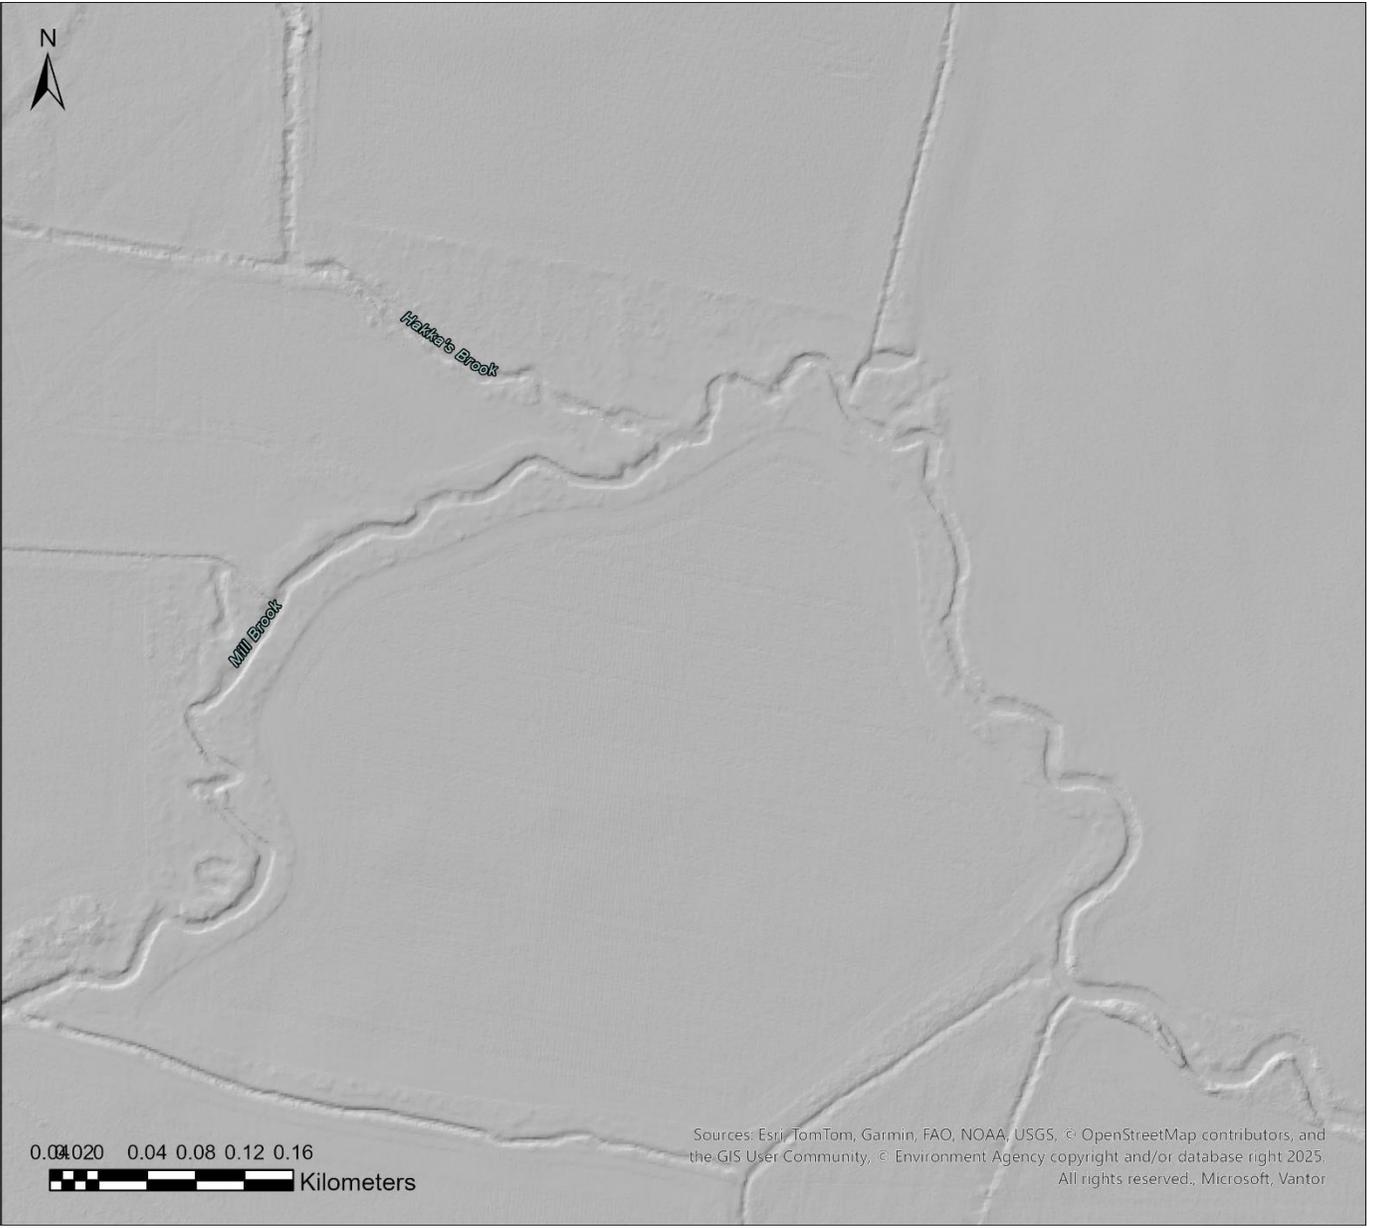
Natural Character and structure

LIDAR Composite
Digital Terrain
Model - 1m (2025)
Hillshade
(Standard)
Value
255
0

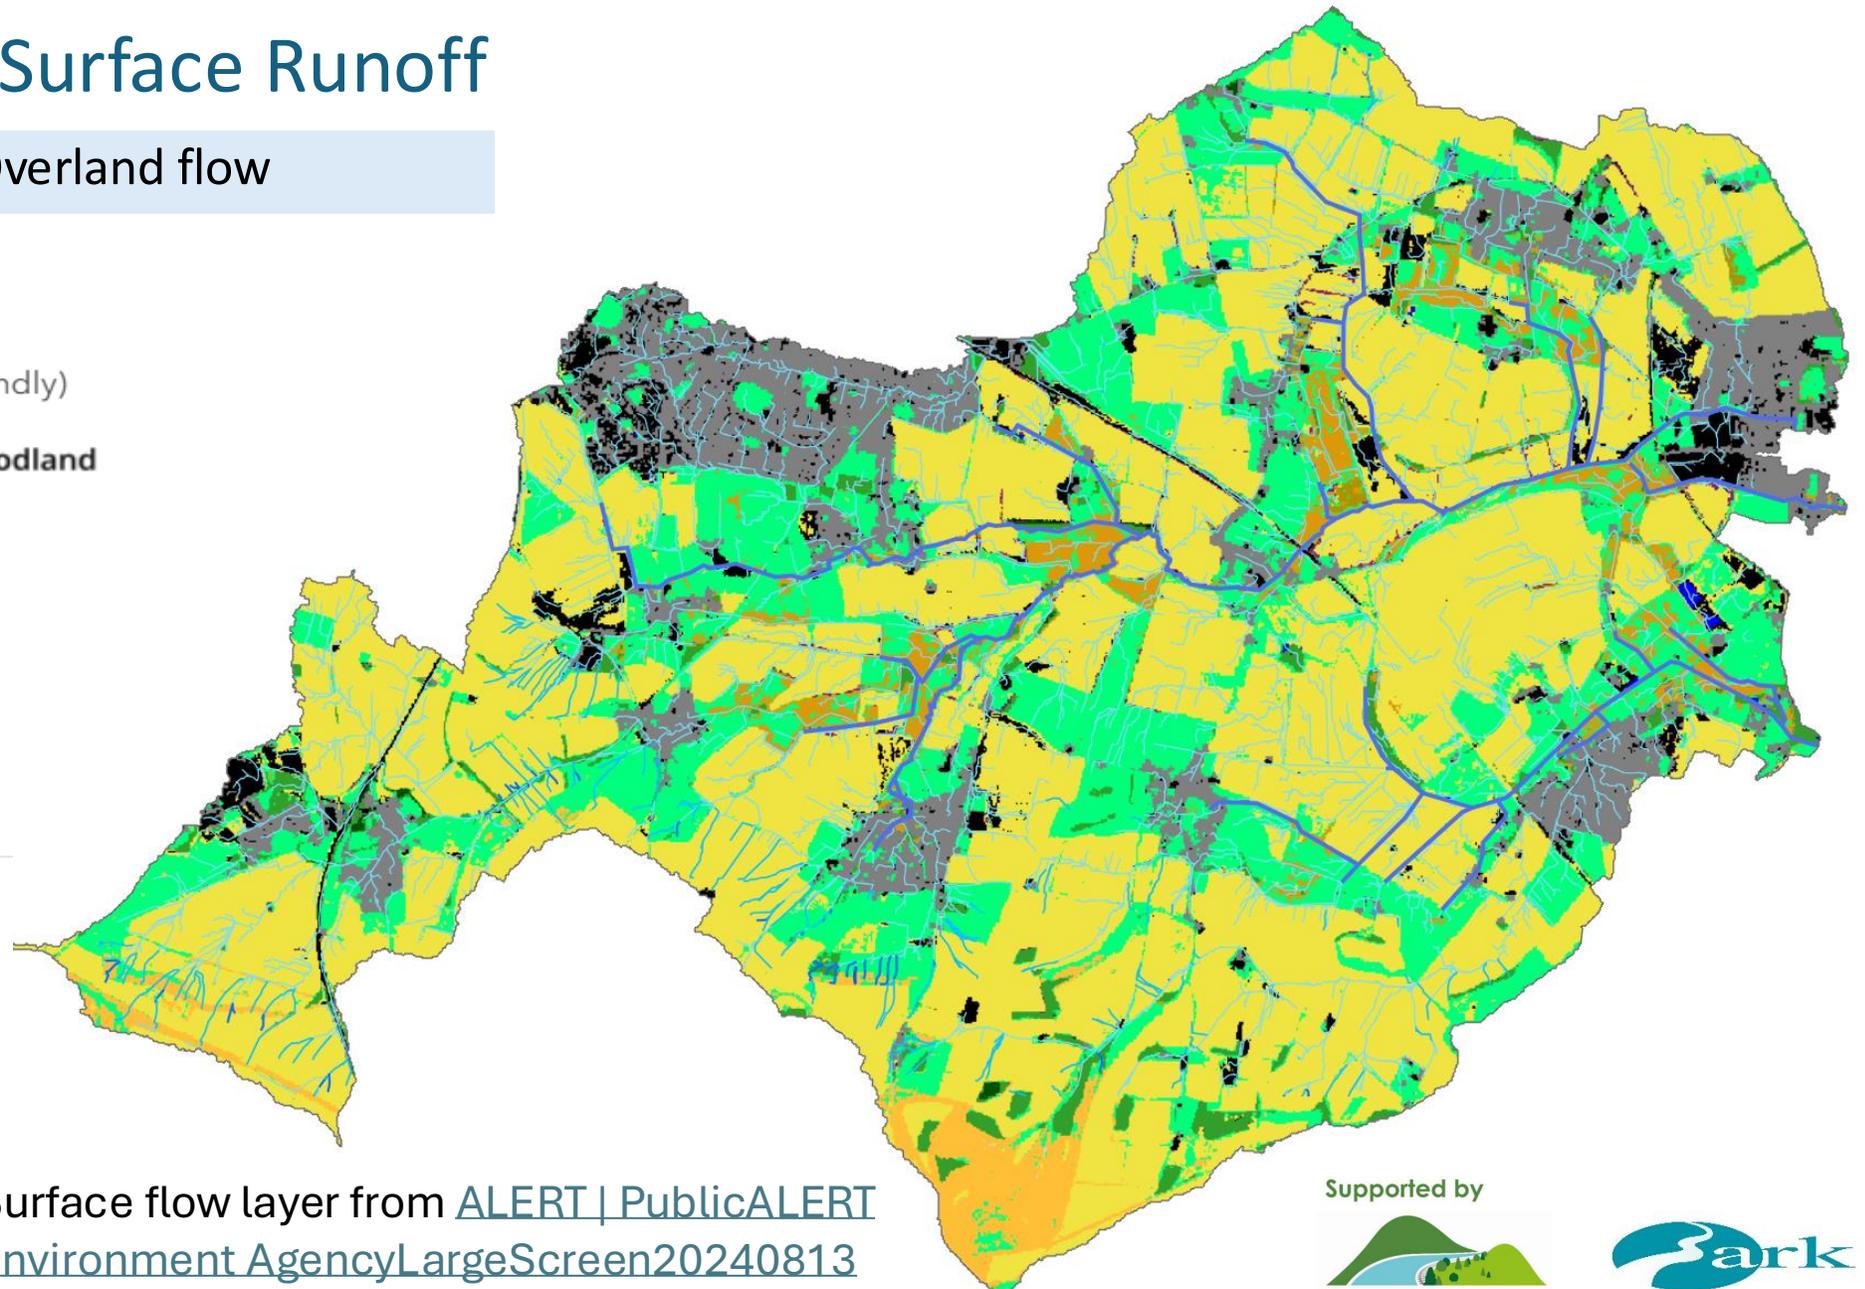
Surface flow layer from [ALERT | PublicALERT Environment Agency LargeScreen20240813](#)

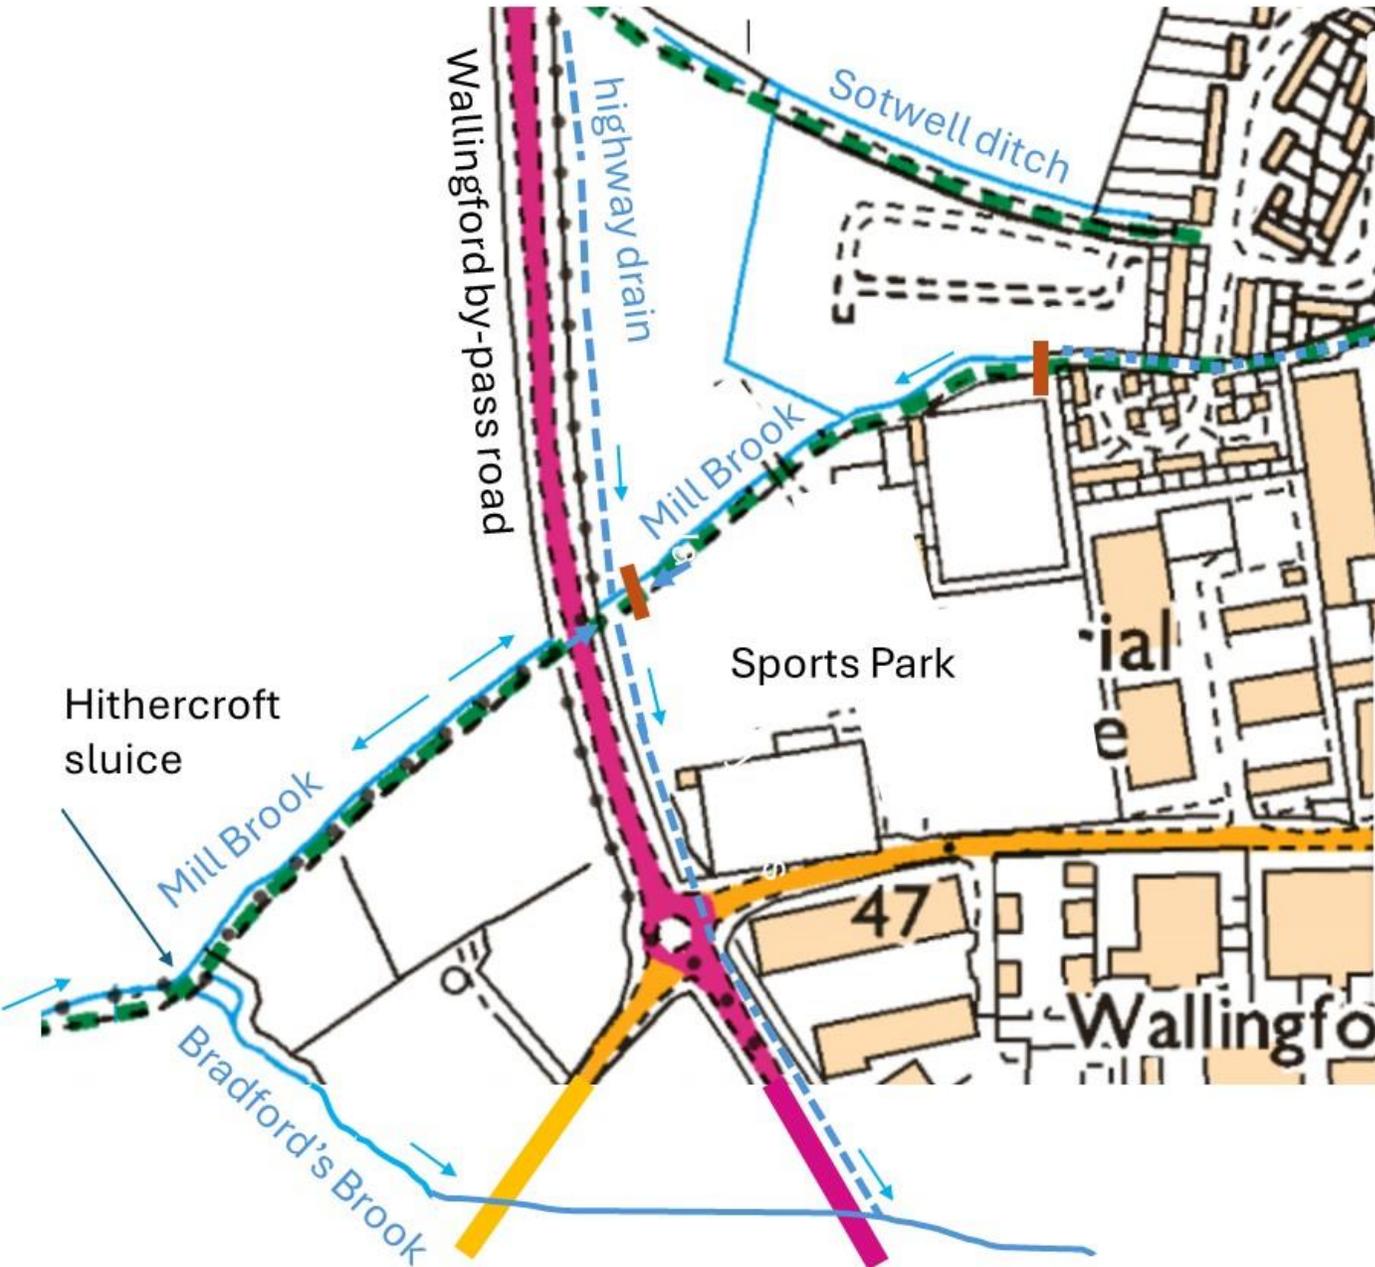
An uphill struggle

1975 water diverted “upstream” to Bradford’s Brook to reduce flooding in town

2015 bypass culvert blocked, water diverted into highway drain to reduce flood risk at Sports Park
